Damage Assessment through Structural Identification of a Three-story Large-scale Precast Concrete Structure

ABSTRACT

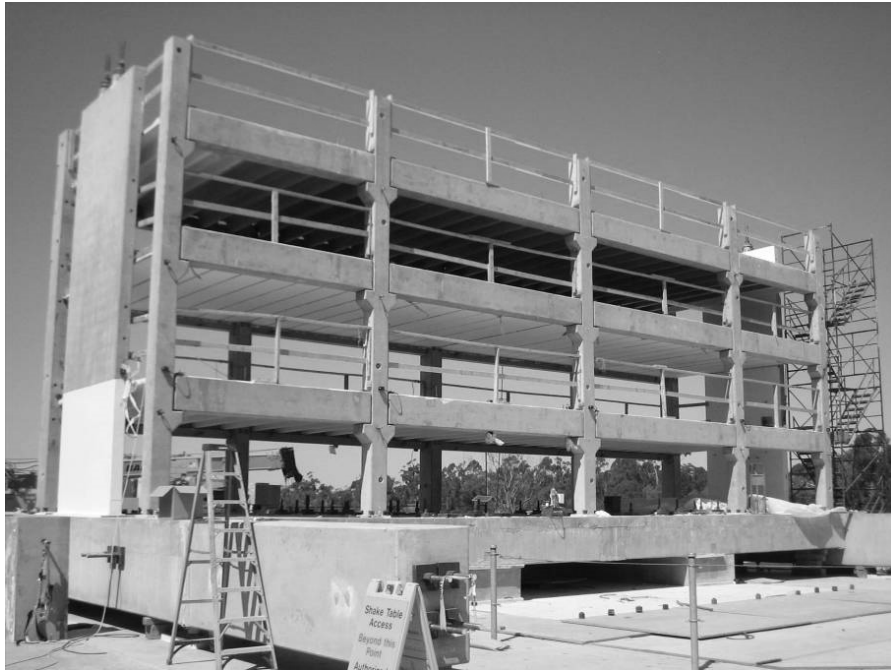
Figure 1 – South-East view of the tested structure.

table platen's footprint (**Figures 1 and 2**), therefore a rigid building foundation was provided in order to transfer the seismic motion to the whole structure without motion amplification. The ends of the rigid foundation were outfitted with massive outrigger beams in order to balance building overturning; two hydrostatic slider bearings, with low coefficient of friction ($< 1\%$), were employed on each outrigger beam to minimize input energy disturbance.

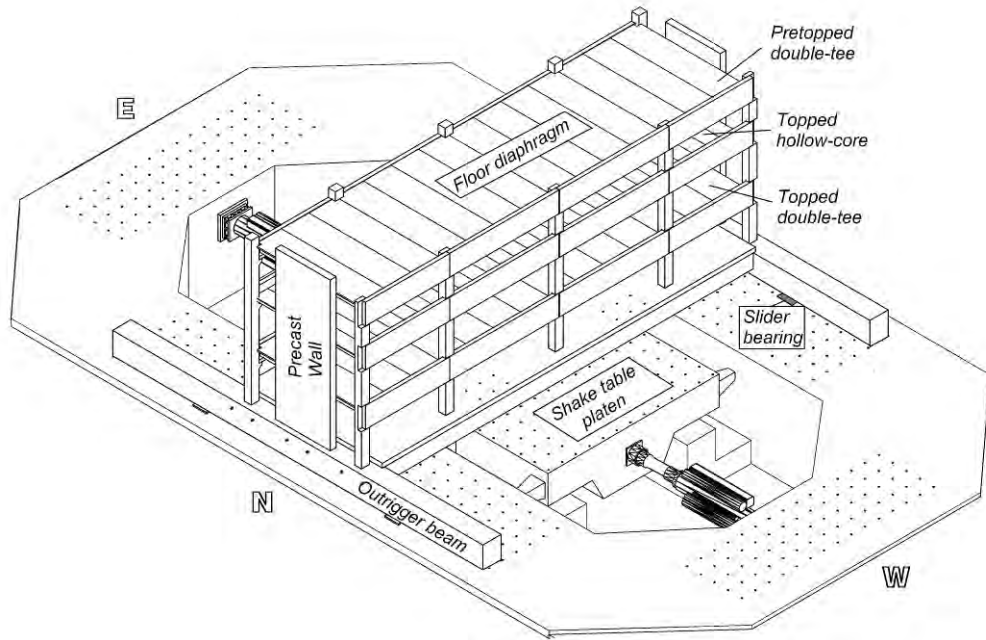
Figure 2 – Shake table test setup.

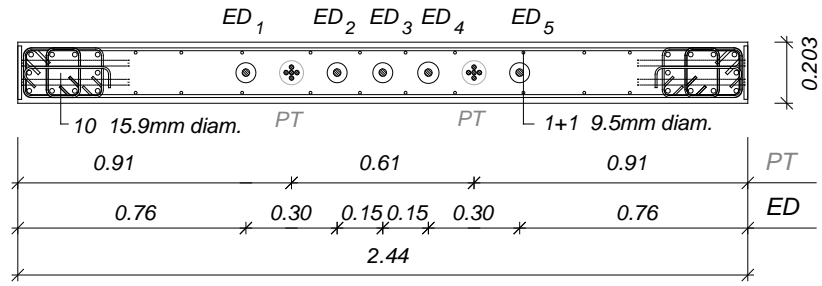
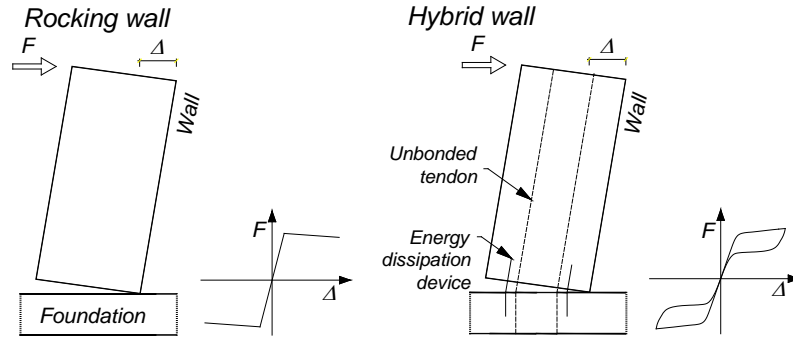
Wall base cross section

Figure 4 – Wall base cross section and schematic behavior.
 Note: dimensions are in meters.

The walls were designed and detailed to act as rocking and hybrid walls [20], with their cross sections and schematic behavior shown in **Figure 4**. These types of systems adopt gravity loading supplemented with unbonded post-tensioned tendons (PT) to ensure self-centering response. A rocking wall displays a nonlinear elastic response under lateral loading with a distinct stiffness reduction in the lateral force-displacement response associated to the uplift of the wall base. A hybrid wall differs from a rocking wall because of the addition of energy dissipation (ED). Compared to traditional reinforced concrete walls, these systems accommodate the lateral displacement seismic demand by the development of a single concentrated opening at the base allowing wall rotation, instead of distributing flexural cracks at the plastic hinge region at the base of the wall. The base of the walls and the bedding mortar where they rest are appropriately detailed to delay the onset of structural damage such as spalling of the concrete.

In each wall of the tested structure, post tensioning was provided by two sets of five, 13 mm (0.5 in.) diameter, unbonded tendons while energy dissipation was provided by 22 mm (7/8 in.) diameter ASTM A 706 reinforcing bars, placed across the wall-foundation joint. Five bars were grouted in the wall footing beam before wall erection and placed in ducts at the bottom of each walls. However, only bars ED₂ and ED₄ (**Figure 4**) were grouted in the wall to provide energy dissipation. Bars ED₁, ED₃ and ED₅ were not grouted to the wall as they were designed as backup devices in the case of early failure of ED₂ and ED₄.

Table 1 reports the shake table base excitations considered in the paper. In tests T1 to T6, the walls were acting as rocking walls, while in the following tests energy dissipation bars ED₂ and ED₄ (**Figure 4**) were grouted leading to a hybrid wall behavior. The table also shows the repair actions taken after damage occurred at the second and third floors [19].

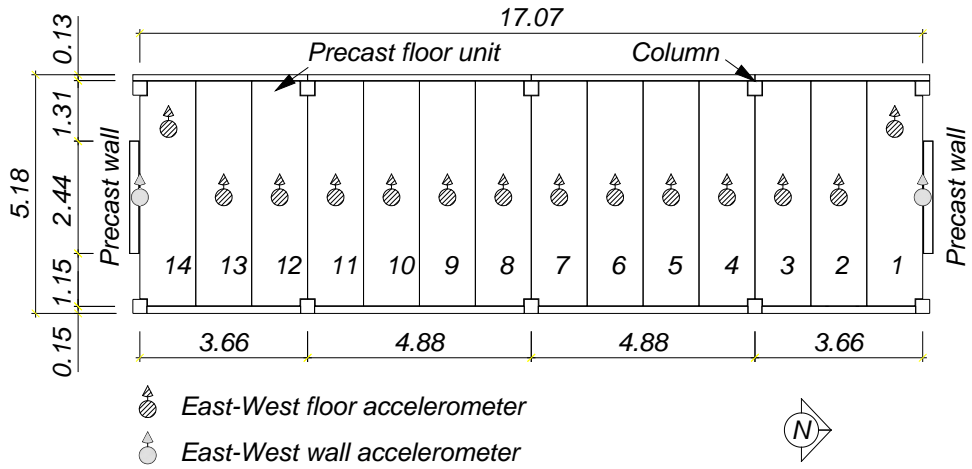
Figure 5 – Floor and wall horizontal accelerometers qualitative position.
 Note: dimensions are in meters.

A comprehensive array of sensors including 640 sensors was deployed on the test structure measuring accelerations, displacements or deformations, strains, and pressures. Only the accelerometers mounted on the floors and on the walls (**Figure 5**) in the direction of shaking were adopted in the system identification procedure. The other accelerometers deployed in the tests recorded base motions or local components of secondary elements not part of the lateral load resisting systems. Other measurement devices such as strain gages and displacement potentiometers provided local vibration response with lower frequency content. All measured data were collected at a sampling rate of 240Hz.

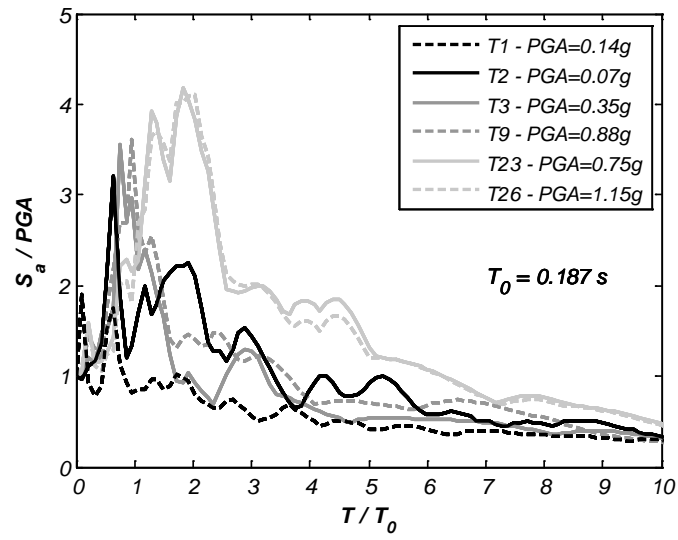
Figure 6 – Pseudo-acceleration response spectra of input ground motions.

Notes: Ground motion records are measured on the table; $\xi = 5\%$; $T_0 =$ specimen fundamental period.

for three sites in the United States: Knoxville (Tennessee), Seattle (Washington) and Berkeley (California). The records were scaled to meet the Design Basis Earthquake (DBE) for the Knoxville (KNX), Seattle (SEA) and Berkeley (BER) sites. After completion of the DBE tests for the three sites, the building was subjected to the Maximum Considered Earthquake (MCE) for the Berkeley site (MCE-BER). Between the seismic tests, the building was subjected to low-amplitude white-noise base excitation (WN) and to small earthquake type loading (EQ-Ch) whose 5% damping pseudo-acceleration response spectrum is shown in **Figure 6**.

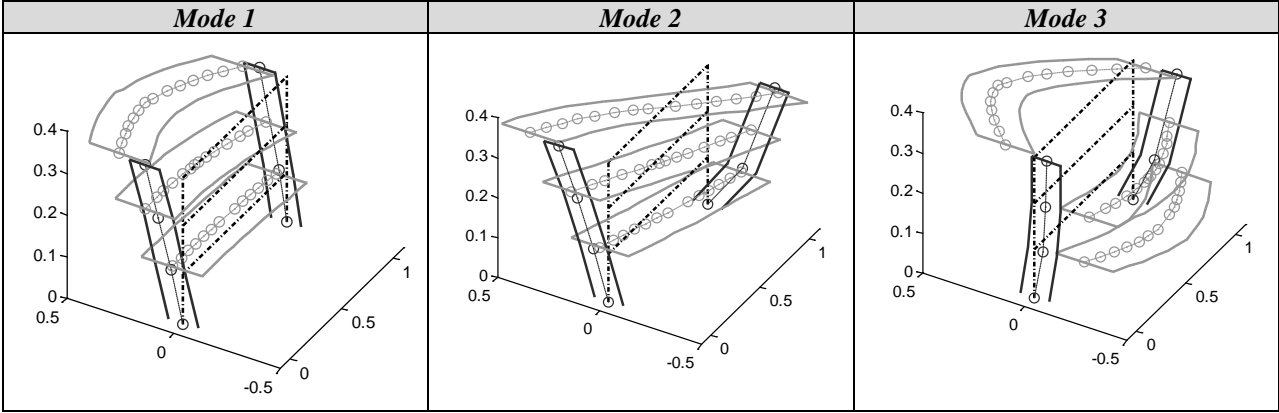
Figure 8 – Test T1 identified mode shapes.

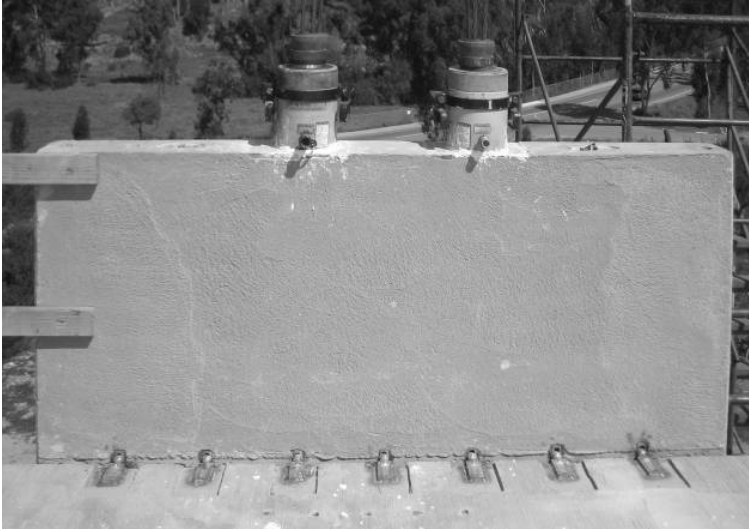
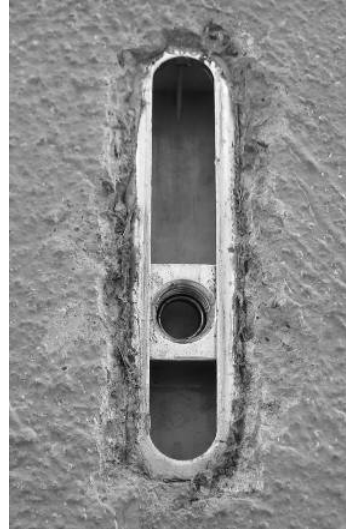
Figure 9 – Floor to wall vertical slotted connections.

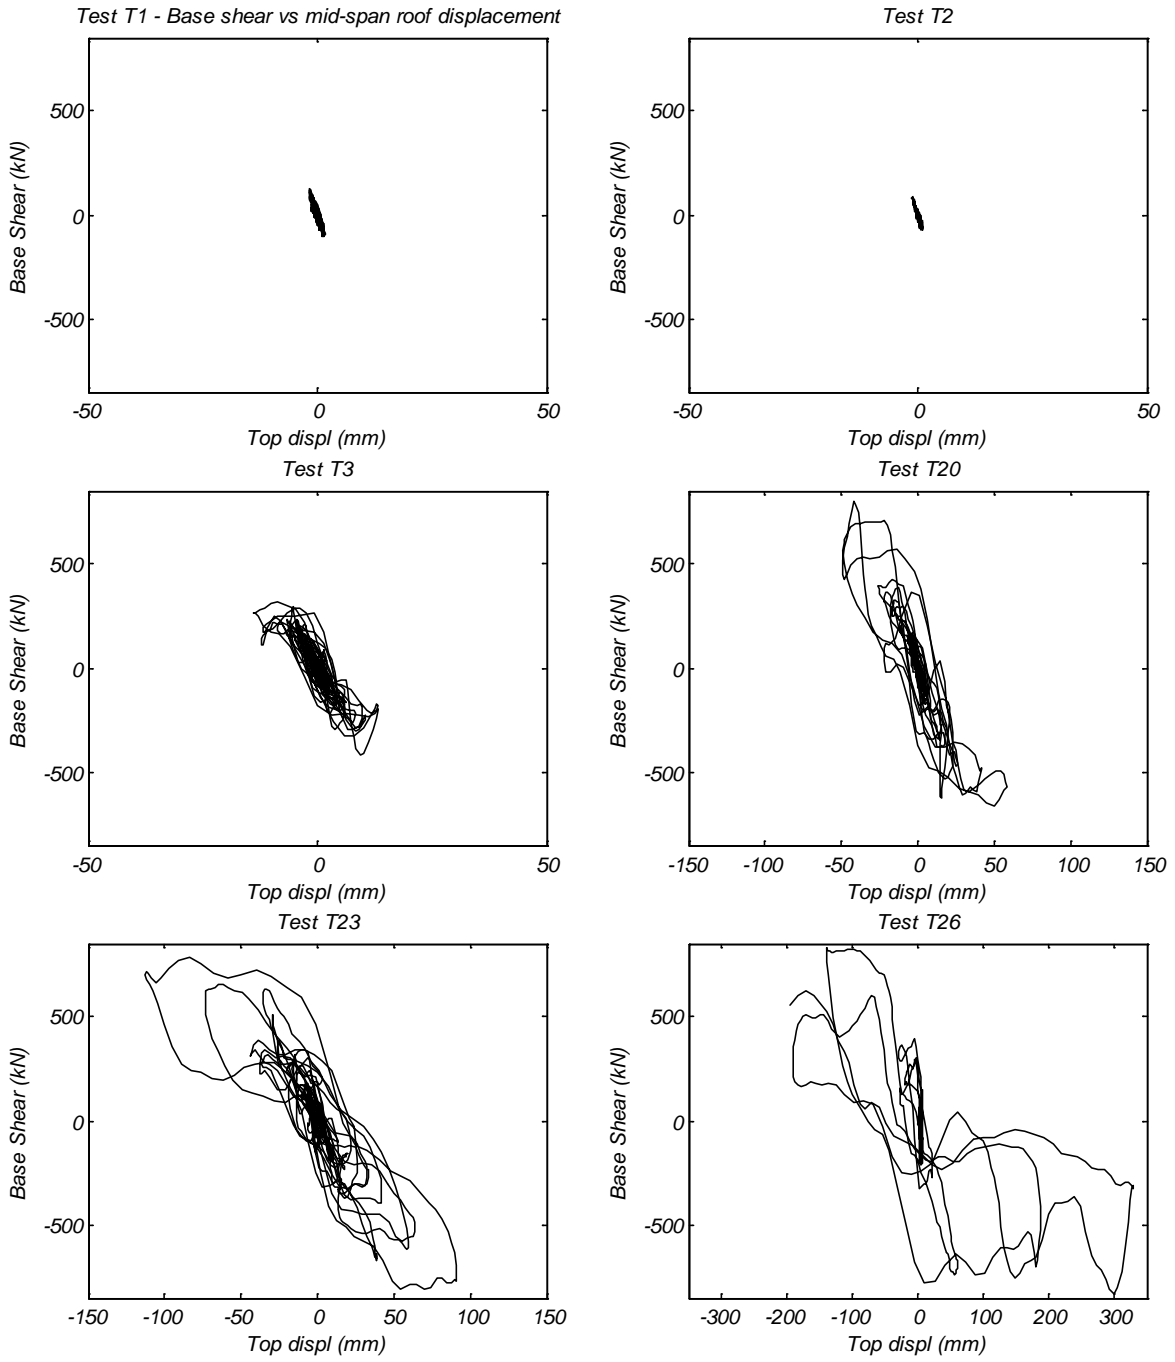
Figure 10 – Base shear versus roof displacement hysteretic plots for selected tests.

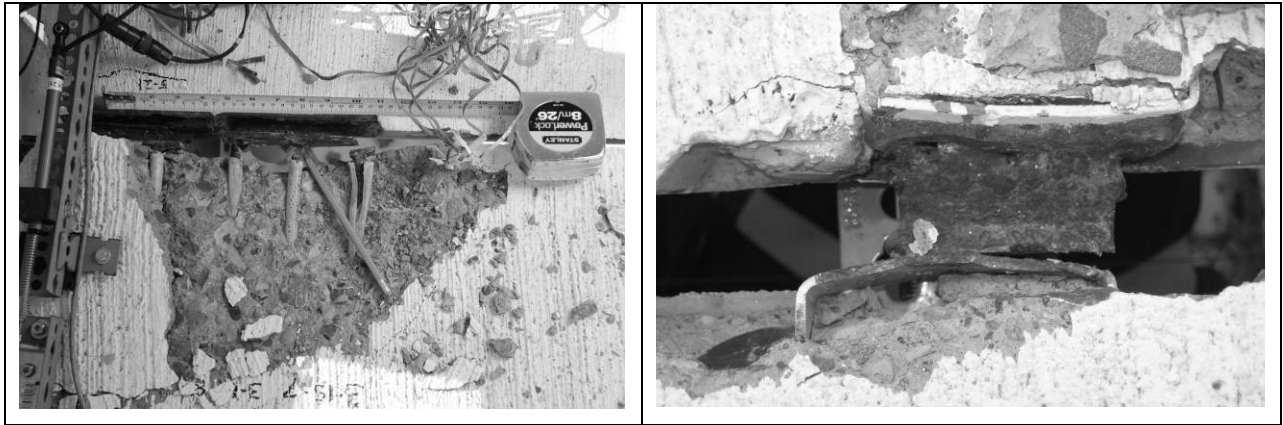
- (4) In general the MAC values for all three modes are in a reasonable range except for tests which exhibited third floor mid-span flexural failure.

Figure 12 –3rd floor mid-span flexural chords and shear keys failure.

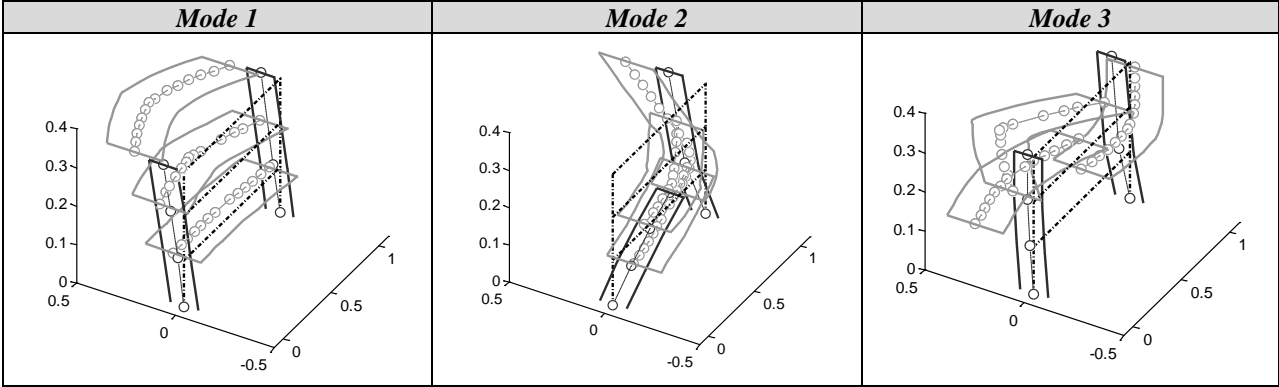
Figure 14 – Identified mode shapes in test T11 after repair.

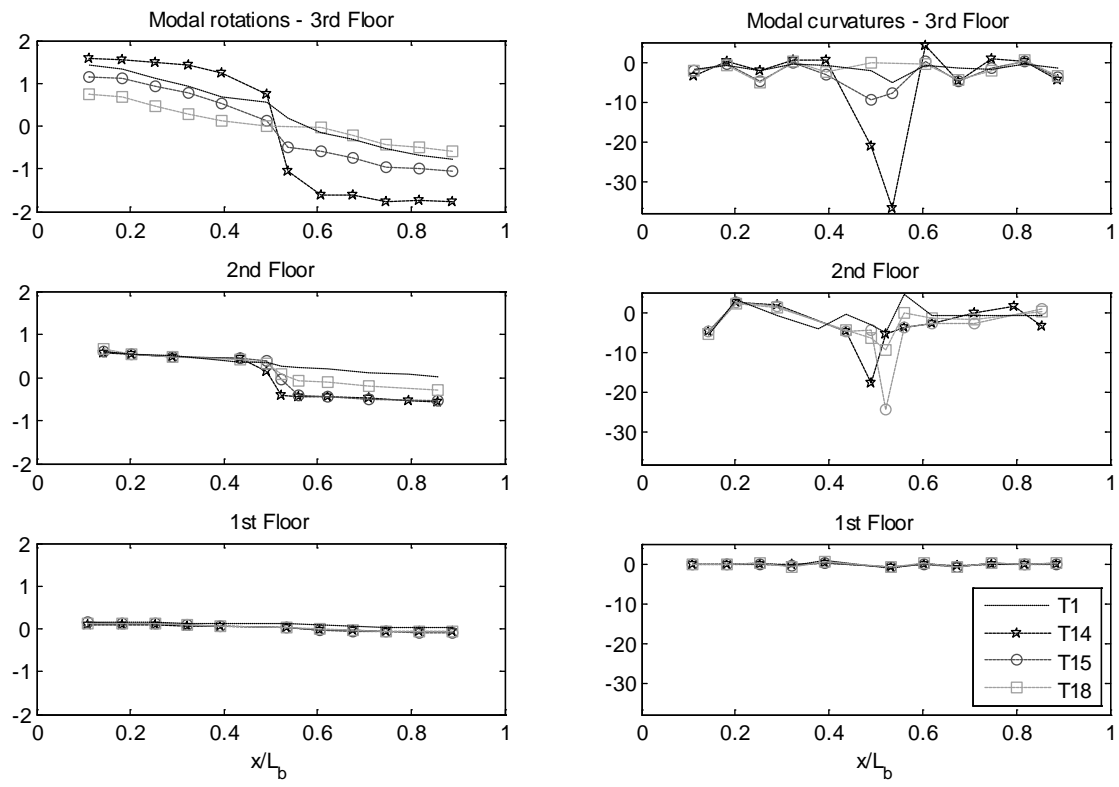
The modal rotations, $\partial v / \partial x$, and curvatures, $\partial^2 v / \partial x^2$, for the three floors in selected tests, T14, T15 and T18, corresponding to damage states S2.3, S2.4 and S2.5, respectively, are presented in **Figure 15** along with those corresponding to the undamaged state S0, test T1. Modal rotations and curvatures are computed using central difference [5] and no smoothing technique is applied. Both modal rotations and curvatures are derived for the first mode shape.

No damage is present in the first floor in accordance to visual observation. In the second floor it is possible to localize both flexure and shear damage at mid-span associated to discontinuities in the modal curvature and rotation plots. Only flexural repair was carried out before test T18 replacing buckled reinforcing bars on the floor East side with a new reinforced concrete curb (**Figure 16**). The flexural repair was not complete as indicated in the modal curvature plot for test T18, probably because damage occurred on the West side reinforcing bars as well. No shear repair was carried out because of lack of visual information, although this did not compromise the structural performance due to the low shear value in that region associated to the test setup. In the third floor both shear and flexural damage can be localized at mid-span in tests T14 and T15 in accordance to visual inspection (**Figure 12**). The repair actions, before test T18, consisted in placing continuous reinforced concrete curbs at the floor East and West sides for flexural repair and a reinforced concrete shear key across the mid-span joint for shear repair (**Figure 17**). In this case the retrofit measures were appropriate as indicated by continuous lines in the modal curvatures and rotations plots for test T18. It is worth noting that the considerations inferred by the modal rotations and curvatures analysis are only valid in terms of flexural and shear stiffness; no information is available regarding flexural and shear strength [30, 31].

Figure 15 – Modal rotations and curvatures for mode 1 in tests T1, T14, T15 and T18.

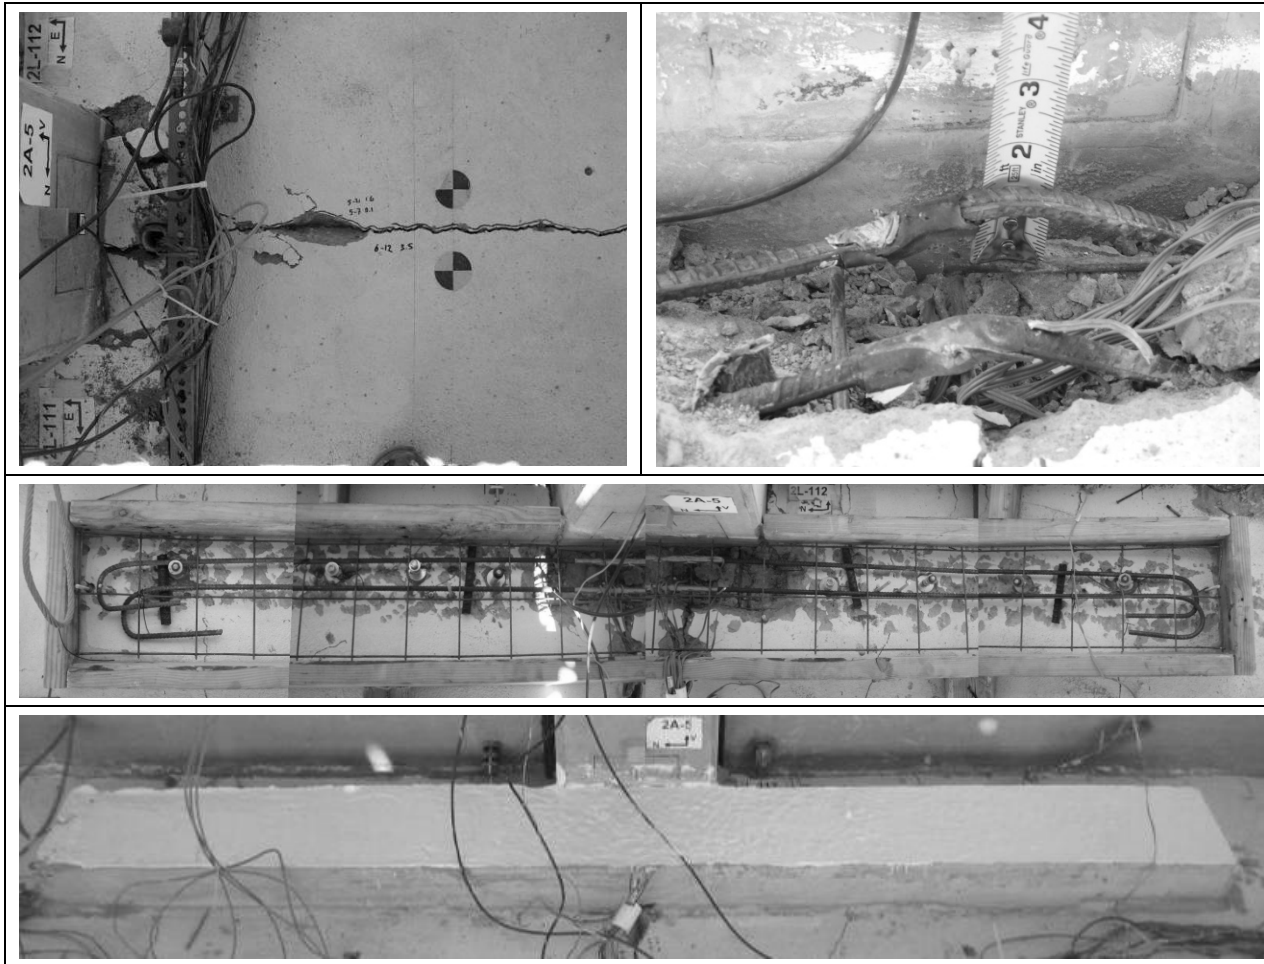
Figure 16 – Mid-span flexural chord damage and repair of East side second floor.
