**A Framework for Comprehensive, Site-Specific Remediation of Polychlorinated
Biphenyl (PCB) Contamination in Pittsfield, Massachusetts**

A Master's Thesis submitted by
Clem Doucette

In partial fulfillment of the requirements for the degree of
Master of Science
in
Environmental Policy and Planning

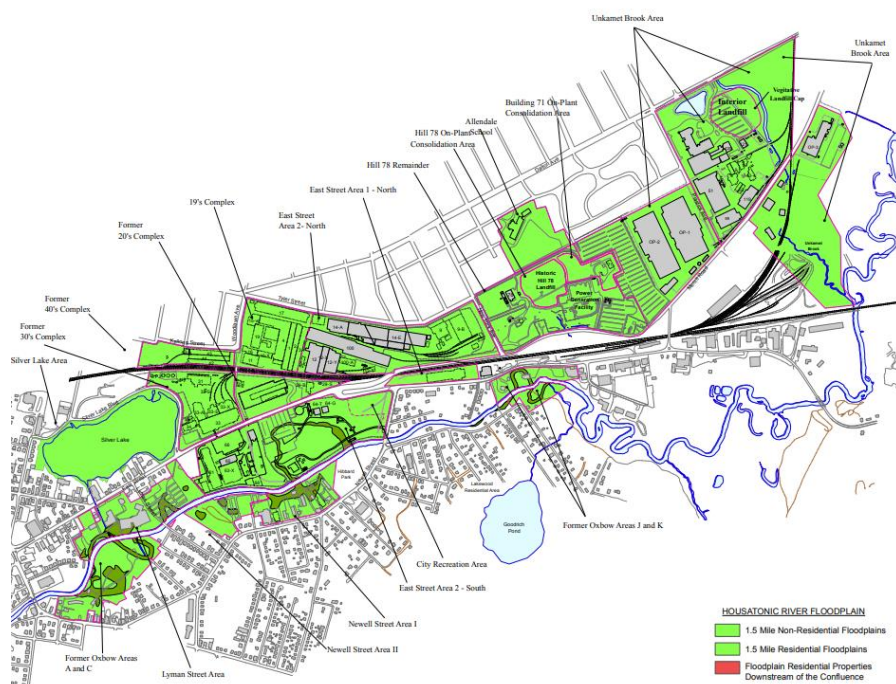
Figure 4: Map depicting the location of the RAAs. Source: United States Environmental Protection Agency.

The site of the former General Electric plant consists of 324 acres of land which includes ten specific Removal Action Areas (RAAs).^[50] Most of these areas are currently access-restricted brownfield land that formerly contained the buildings and other improved lands of the General Electric facility. Portions of the site are bisected by a CSX rail right-of-way, and some small CSX-owned facilities are located on the former plant site.^[50] The present conditions and remediation statuses of the ten RAAs are described below.

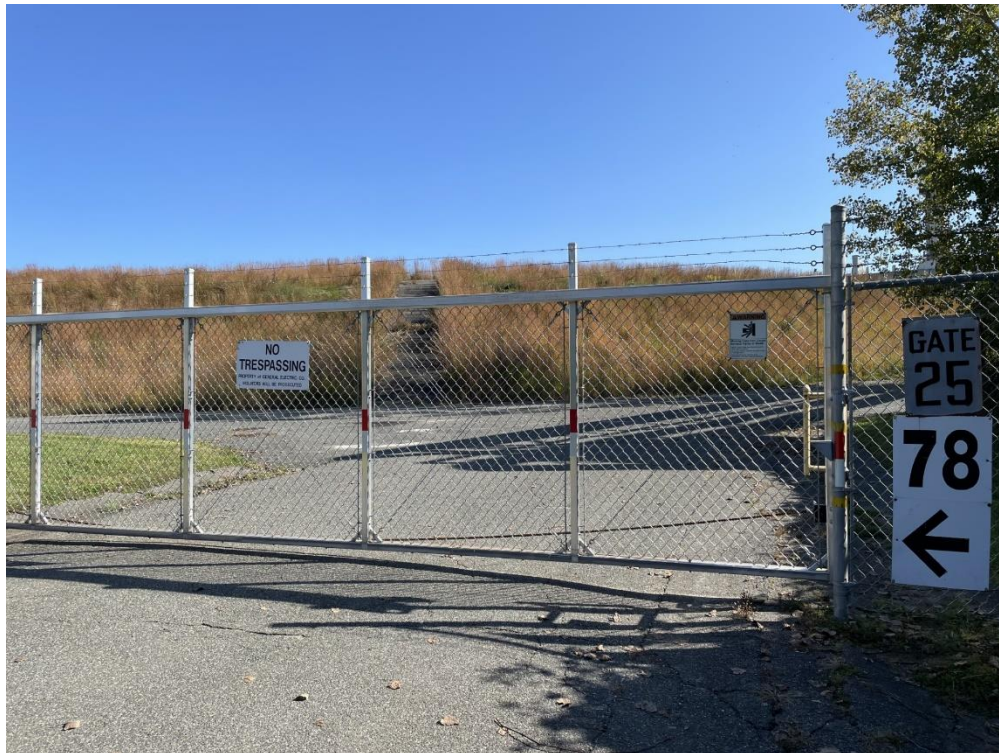
Figure 5: The Hill 78 OPCA. Source: self.

the plant.^[28] In 1991, General Electric installed a temporary cap on the landfill. After designation as a consolidation area by the EPA, approximately 134,500 cubic yards of contaminated material was disposed of at the site between 1999 and 2009.^[61] Material deposited at Hill 78 was required to contain no greater than 50 ppm of PCB.^[61] After the area was filled in 2009, it was sealed with a multilayer cap consisting of an impermeable high-density polyethylene (HDPE) liner, a geosynthetic drainage composite layer, eighteen inches of sand, and six inches of topsoil with a vegetative cover.^[28, 62]

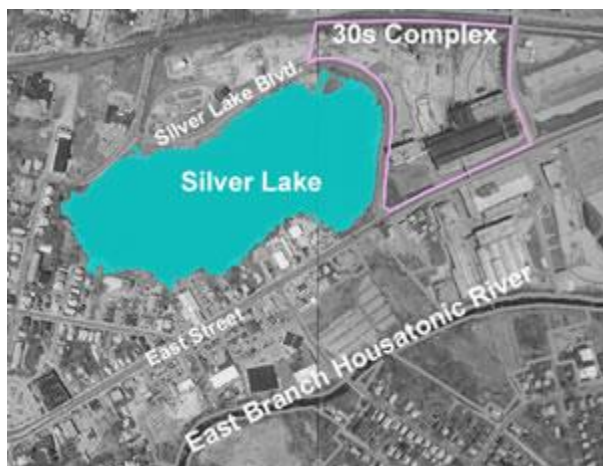
Figure 4: Silver Lake in relation to the former General Electric Plant 30s Complex. Source: United States Environmental Protection Agency

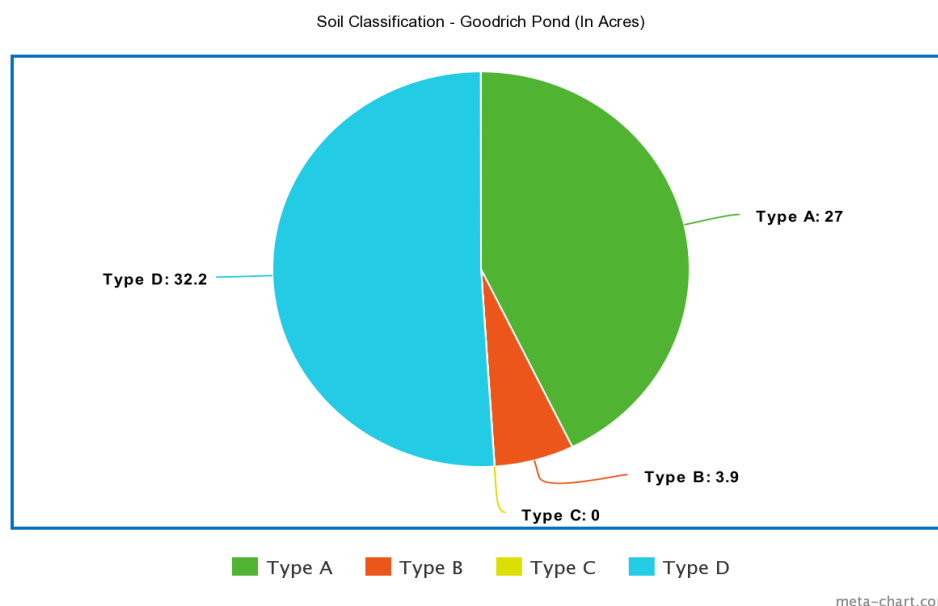
Figure 9: Chart depicting share of soil type classification within the Goodrich Pond Watershed, in acres. Source: USDA Web Soil Survey.

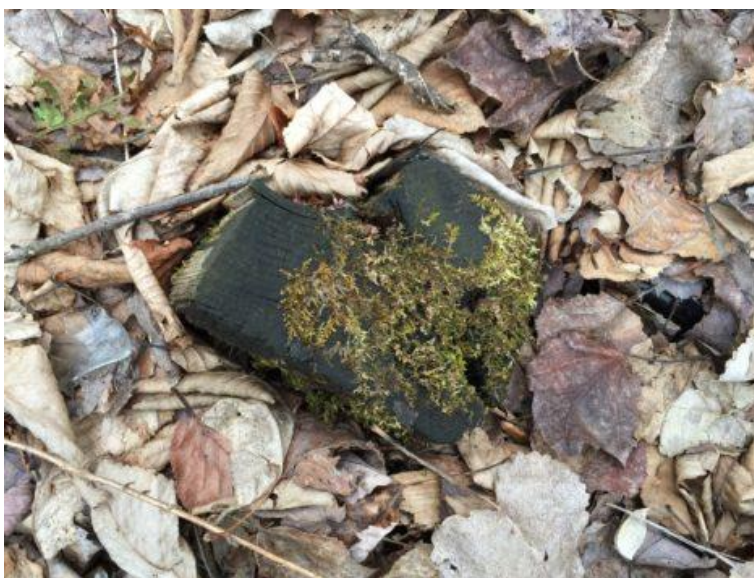
Figure 10: A PCB-saturated creosote brick in Brattle Brook Park. Source: Heather Bellow, Berkshire Edge, 2016.

at the site and that local youth would sometimes handle or play with the contaminated bricks.^[79] The possible continued presence of PCB-containing creosote bricks at the site warrants further investigation and may present risks for uninformed visitors to the park, especially children who are unaware of the purpose of the bricks.

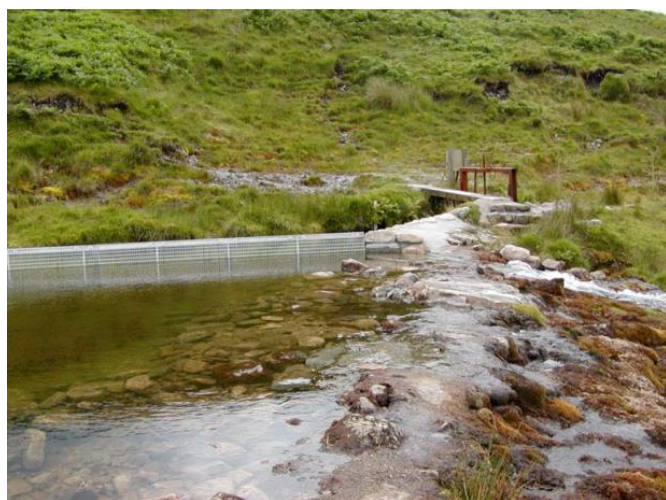
Figure 14: A passive mesh screen in Devon, UK. Source: United Kingdom Environment Agency.

In accordance with NMFS guidelines, the approach velocity of flow entering the screen must not exceed 0.20 ft/s for passive mesh screens.^[45] Regarding mesh aperture, 3/32-inch openings are a maximum allowable size established by various regulatory bodies, including the NMFS, the National Oceanic and Atmospheric Administration

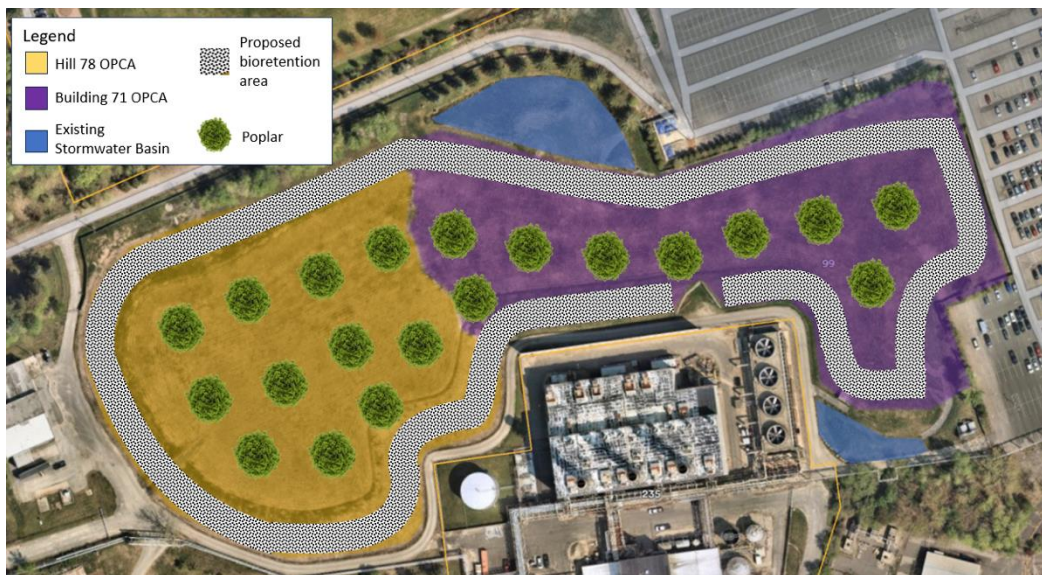
Figure 16: A rendering of a potential bioremediation plan for the Hill 78 and Building 71 OPCAs. Note: tree placement is illustrative and not to scale.

The figure above depicts an aerial view of the Hill 78 and Building 71 OPCAs, showing existing conditions and infrastructure, along with the proposed bioremediation initiative. The Hill 78 and Building 71 sites rise approximately 15 to 20 feet above the surrounding land and are encircled by a ring of flat to slightly depressed earth that measures approximately 50 feet in width.^[28, 47] The proposed design suggests the planting of poplar trees throughout the elevated portions of the OPCAs, with a vegetated bioretention area constructed in the depressed area surrounding the sites. The poplar tree plantings would restore, remediate, and prevent erosion of the post-treatment soils, and the bioretention barrier is designed to capture and treat any stormwater runoff that flows off the hill.^[127, 128, 136] Constructing this barrier would augment the existing on-site stormwater basins and allow for increased capture and treatment of runoff.^[127, 128]

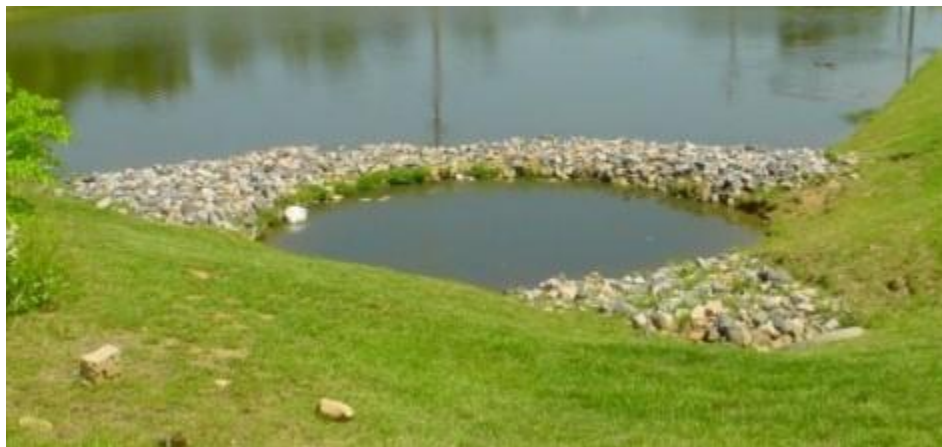
Prior to entering the bioretention area, stormwater is pre-treated using a series of sediment forebays.^[127] These consist of an excavated pit combined with a weir.^[192] The purpose of the forebay is to slow the velocity of incoming stormwater and facilitate the separation of suspended solids prior to entering the bioretention area.^[192] Sediment forebays are easily accessible and cleanable for sediment removal, prevent the bioretention area from becoming clogged with sediment, and moderate the flow of stormwater entering the bioretention area.^[127, 192] In Massachusetts, MassDEP regulations require the construction of a sediment forebay as a pretreatment device for stormwater discharge into a bioretention area or comparable device.^[127]

Figure 18: A sediment forebay. Source: Massachusetts Clean Water Toolkit.
