**Incidence of Vertical Root Fracture at the Apical Third of the
Root Canal System after Preparation with Newer NiTi Rotary Files and
Hand Files at Different Working Lengths**

A Thesis

by
Afnan Abdulmajeed
04/2018

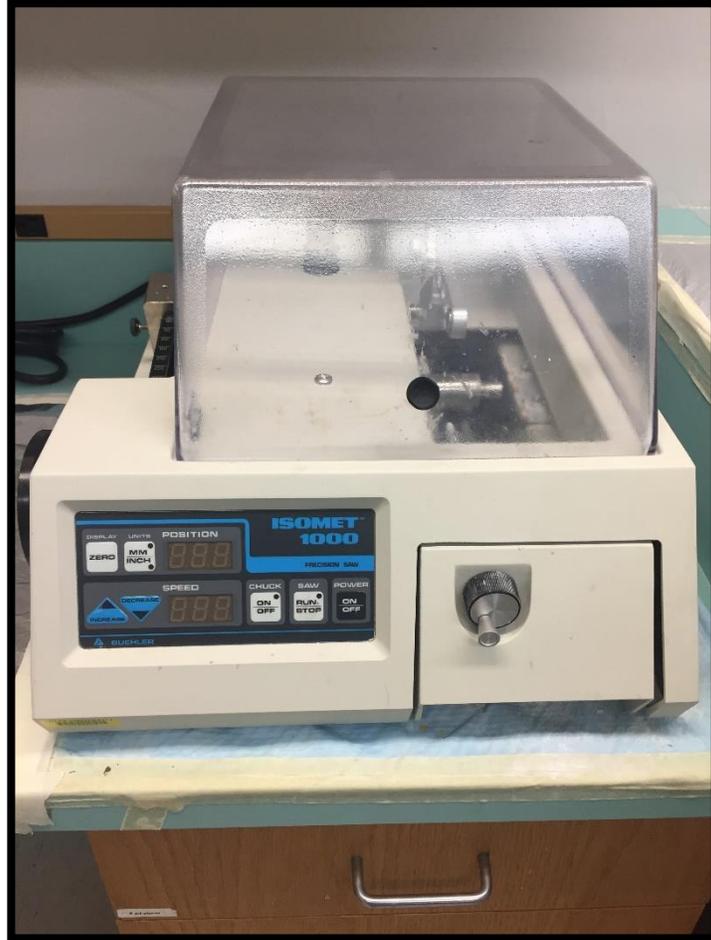
Figure 1: Isomet 1000 (Buehler Ltd)

All roots were sectioned horizontally at 2 mm from the apex with an Isomet 1000 Precision saw (Buehler Ltd, Evanston, IL, USA) under water coolant.³ Slices were observed under a stereomicroscope (Carl Zeiss, Oberkochen, Germany) using a cold light source (KL 2500 LCD; Carl Zeiss). Pictures were taken with a digital camera (Canon 6D) attached to a stereomicroscope under 13.6X magnification. The dentin was inspected and defects were noted. The samples were initially evaluated by three examiners: first and second year postgraduate endodontic residents who were not involved in the specimen preparation. The dentinal defects were categorized according to the Wilcox et al. classification:³⁹

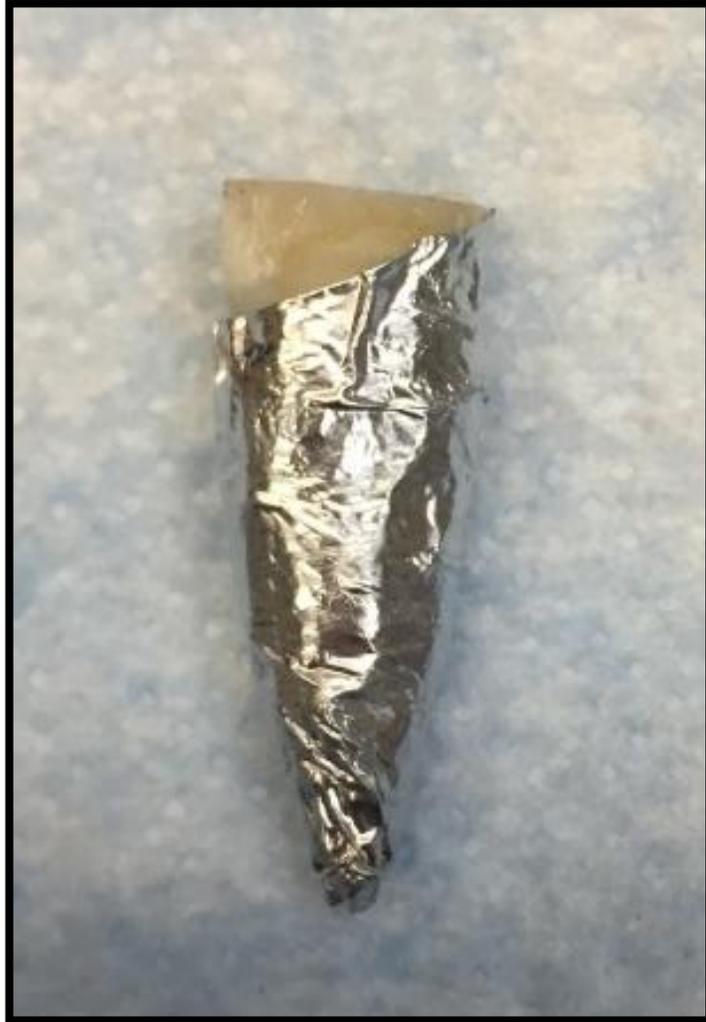
Figure 2: All roots were wrapped in a single layer of aluminum foil

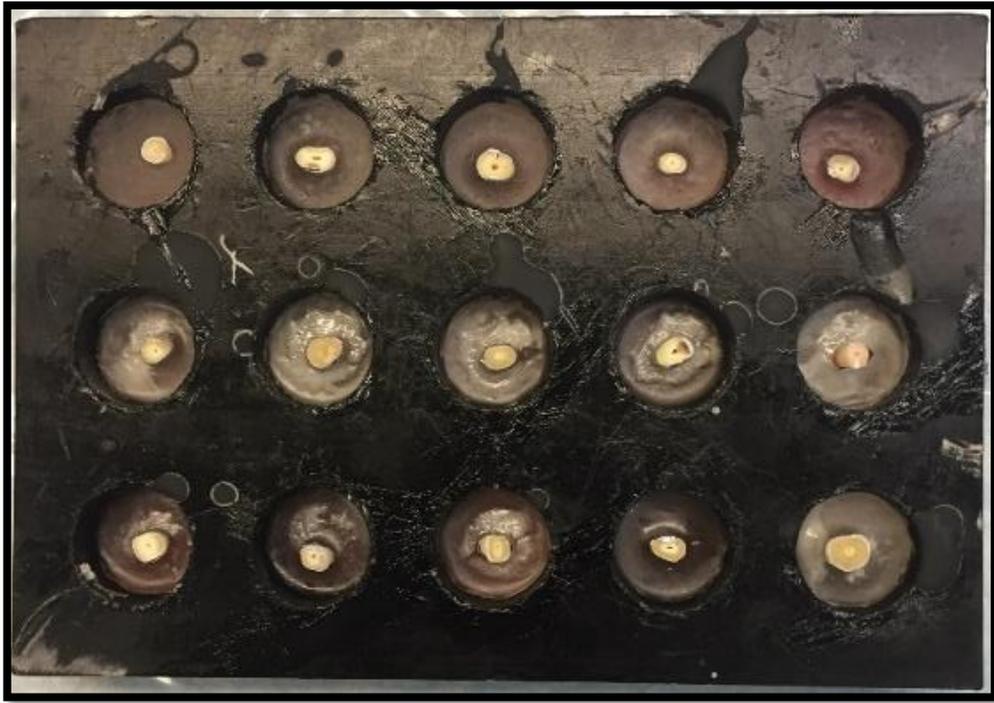
Figure 3: All teeth were embedded in autopolymerizing acrylic resin until set

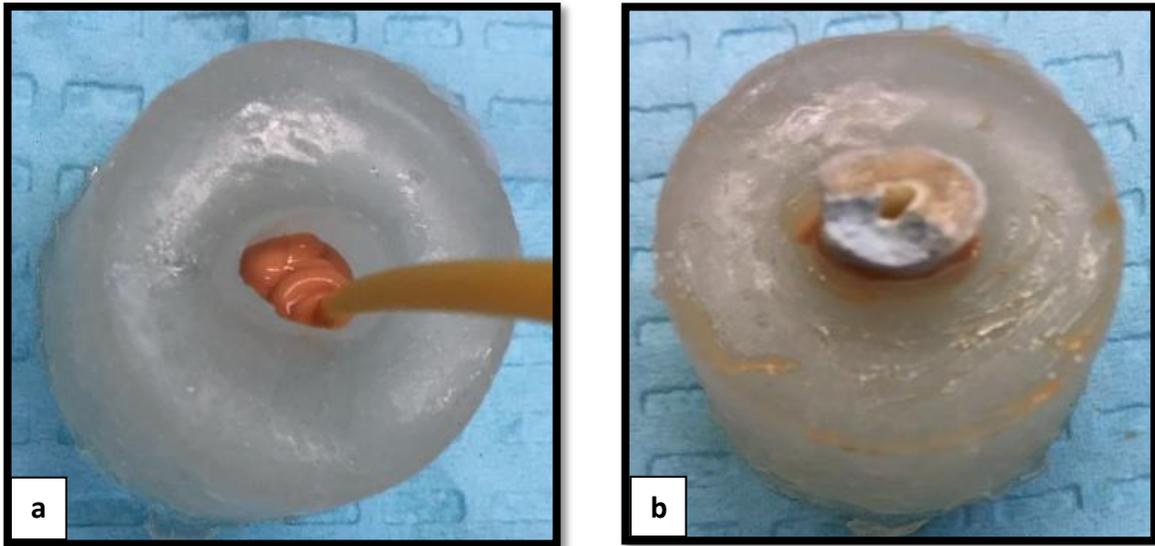
**Figure 4: a) The “sockets” were filled with a hydrophilic vinyl polysiloxane impression material
b) The teeth were reinserted into the created “sockets”**

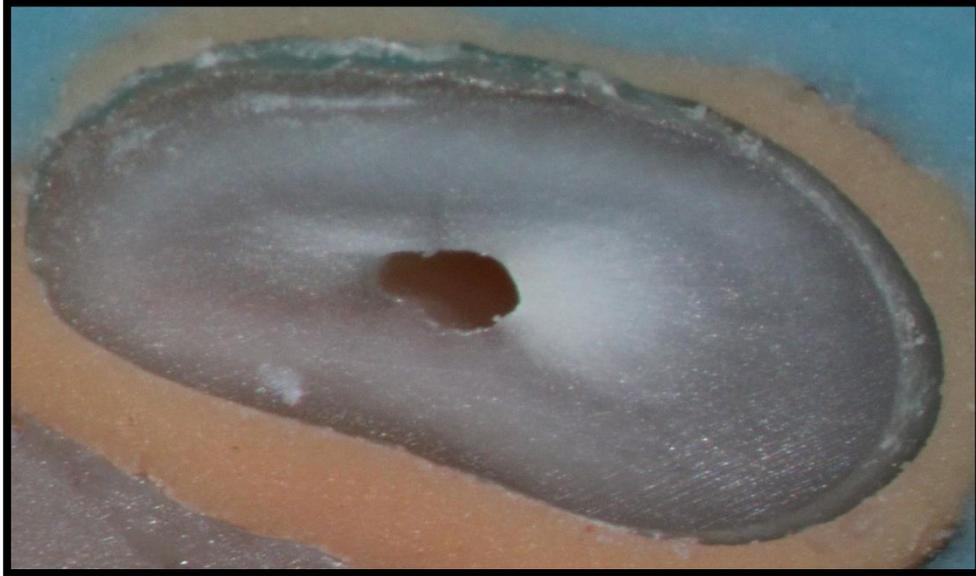
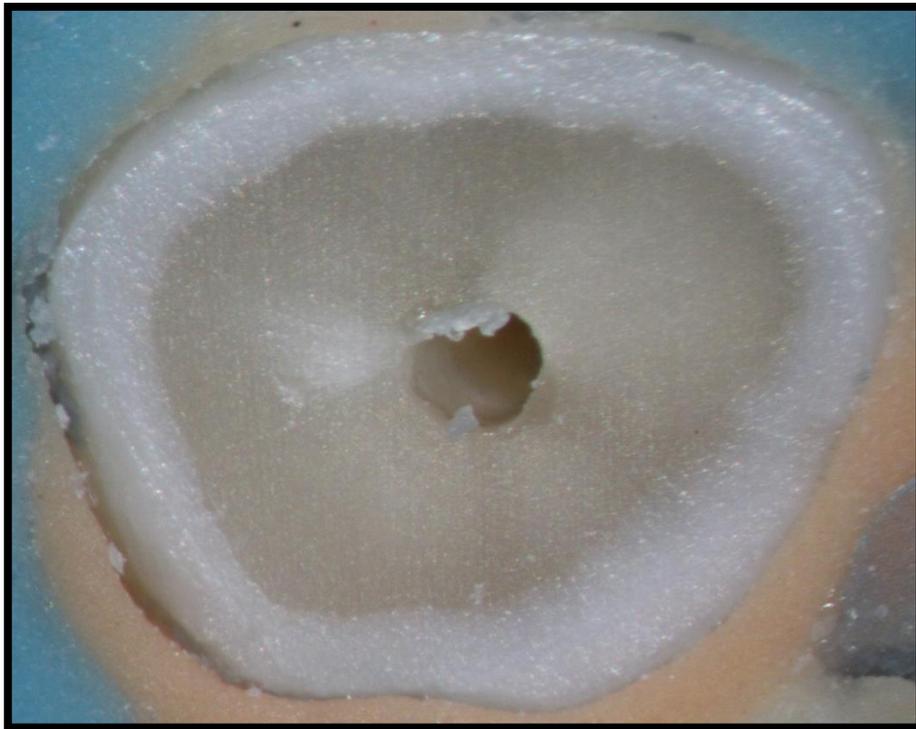
Figure 5: Microscopic images showing no defects at 2 mm level

1. **No defect:** defined as root dentine devoid of any line or crack either at the external surface of the root or at the internal surface of the root canal wall.
2. **Complete fracture:** defined as a line extending from the root canal space to the outer surface of the root.
3. **Incomplete fracture:** defined as all other lines observed that did not extend from the root canal to the outer root surface such as craze lines which extend from the outer surface into the dentin but do not reach the canal lumen or a partial crack which extend from the canal wall but do not reach the external surface of the root.

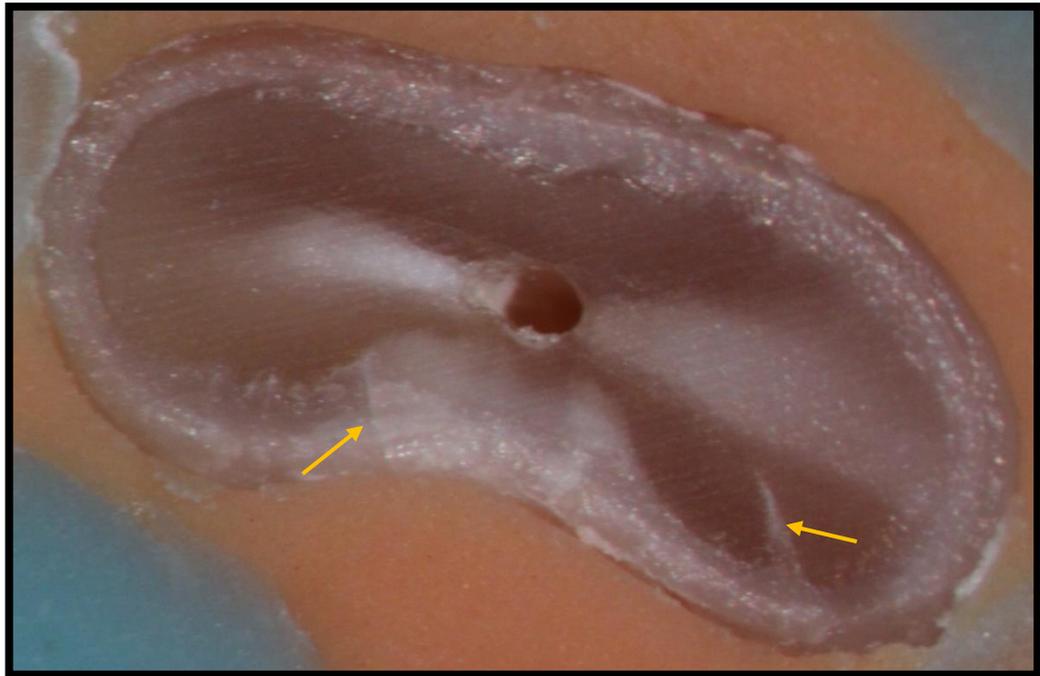
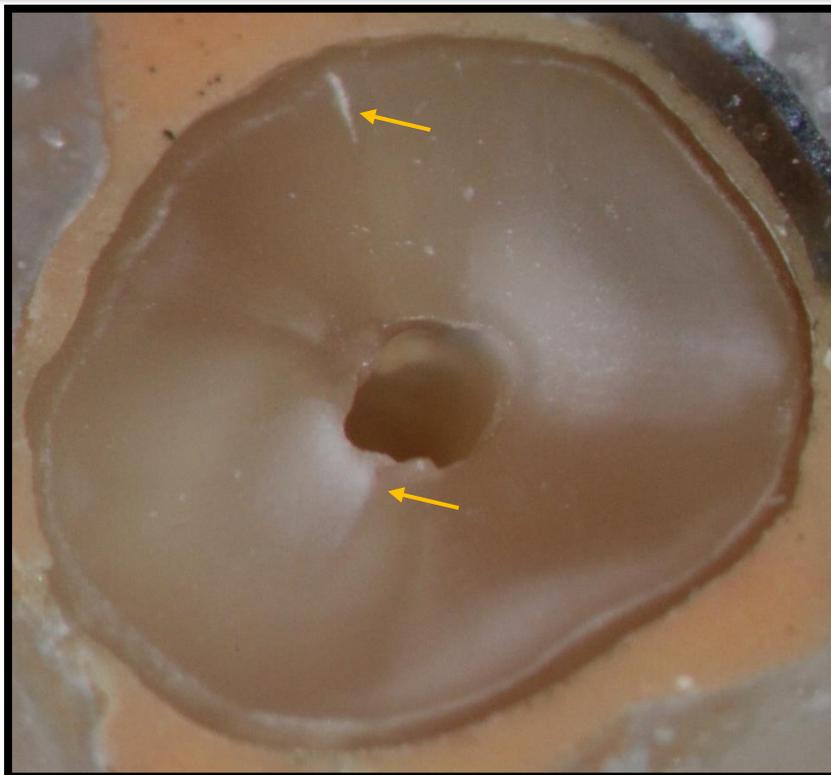
Figure 6: Microscopic images showing incomplete fracture at 2 mm level

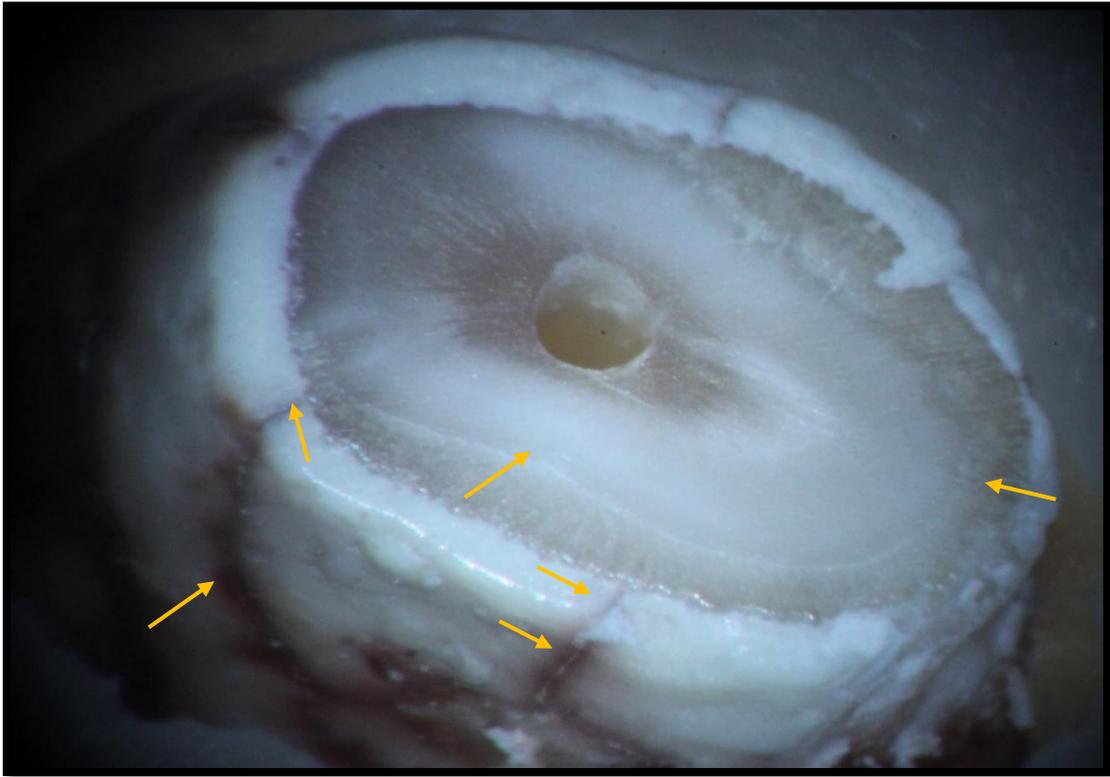
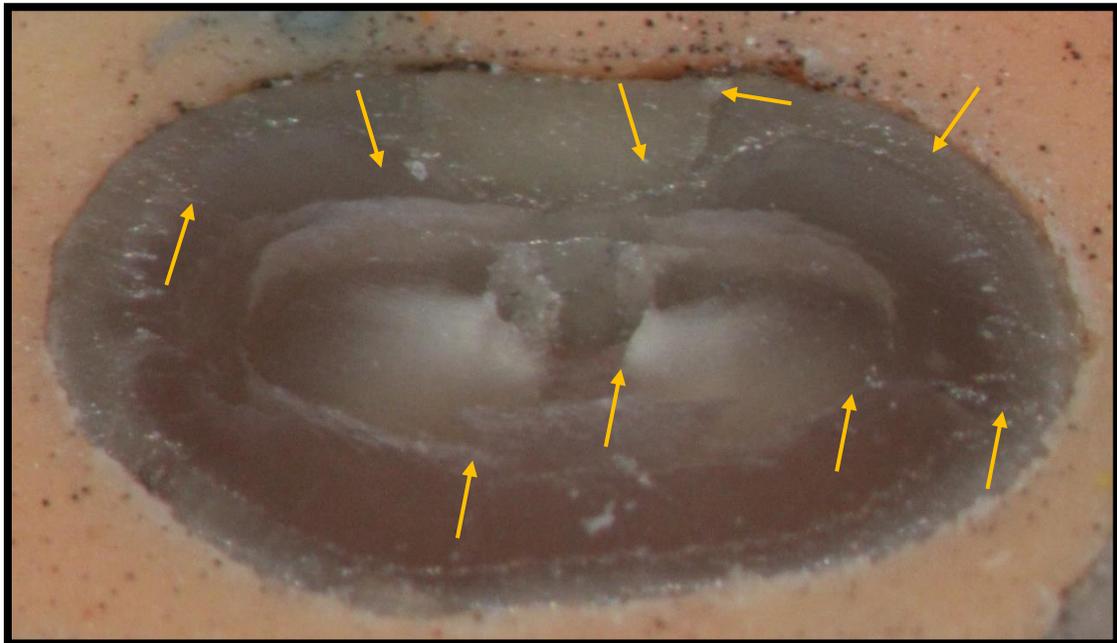
Figure 7: Microscopic images showing complete fracture at 2 mm level
